GREENWOOD PARK

Stream Restoration

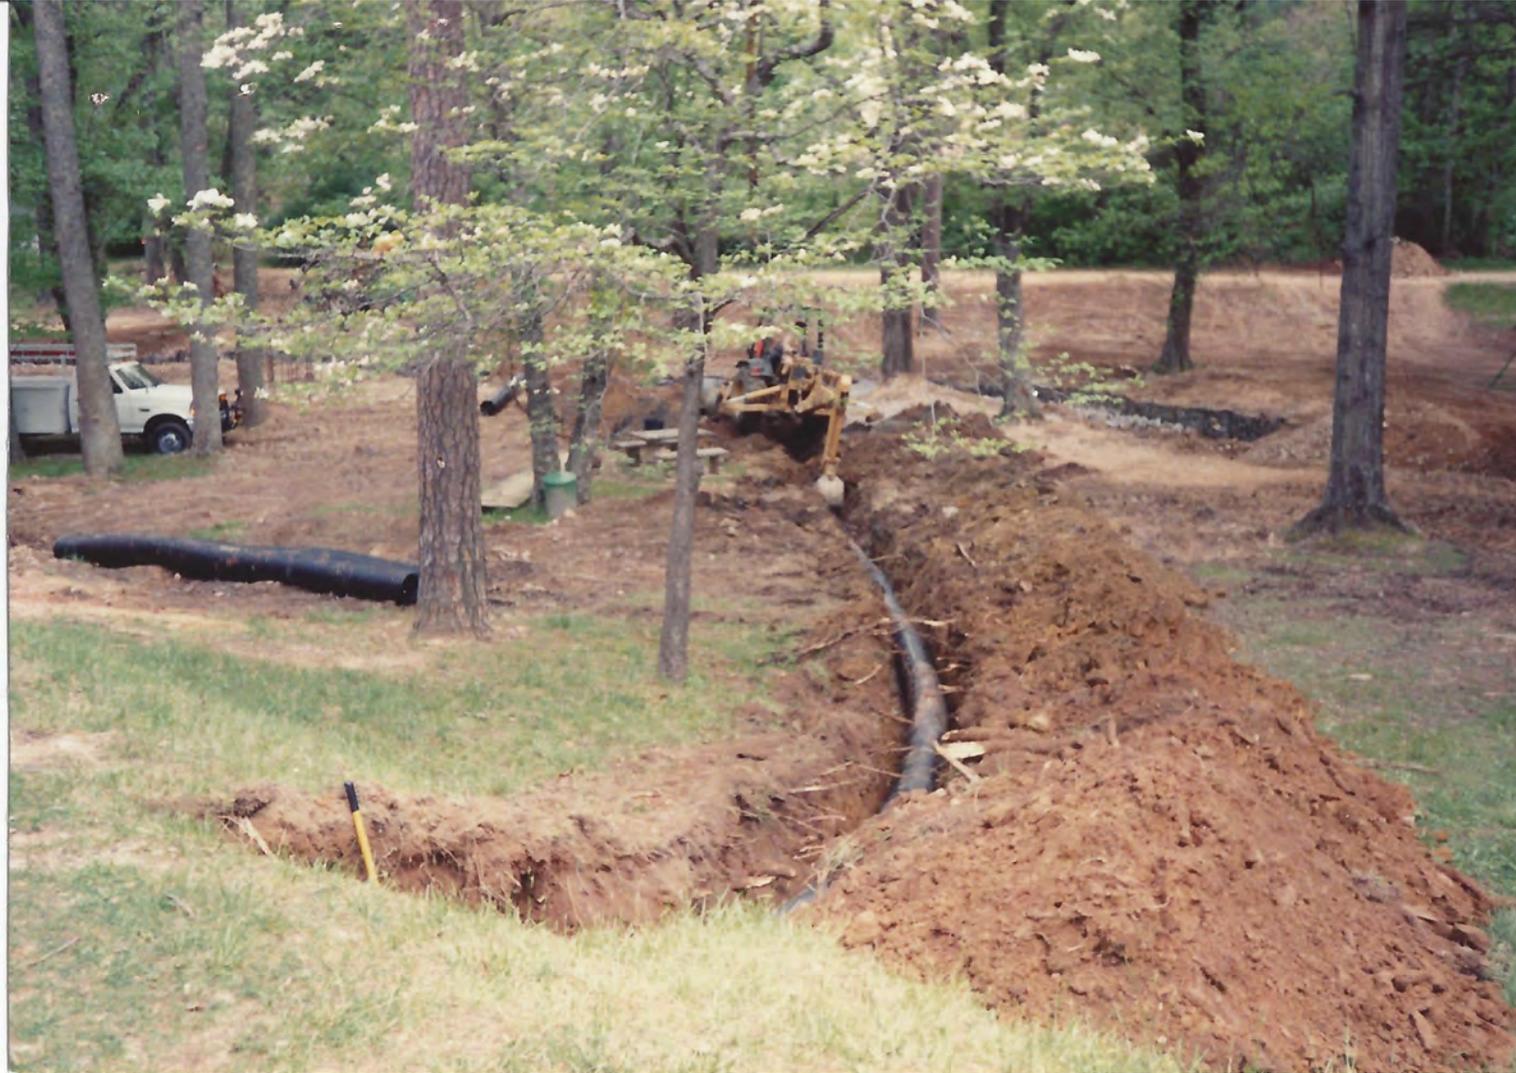
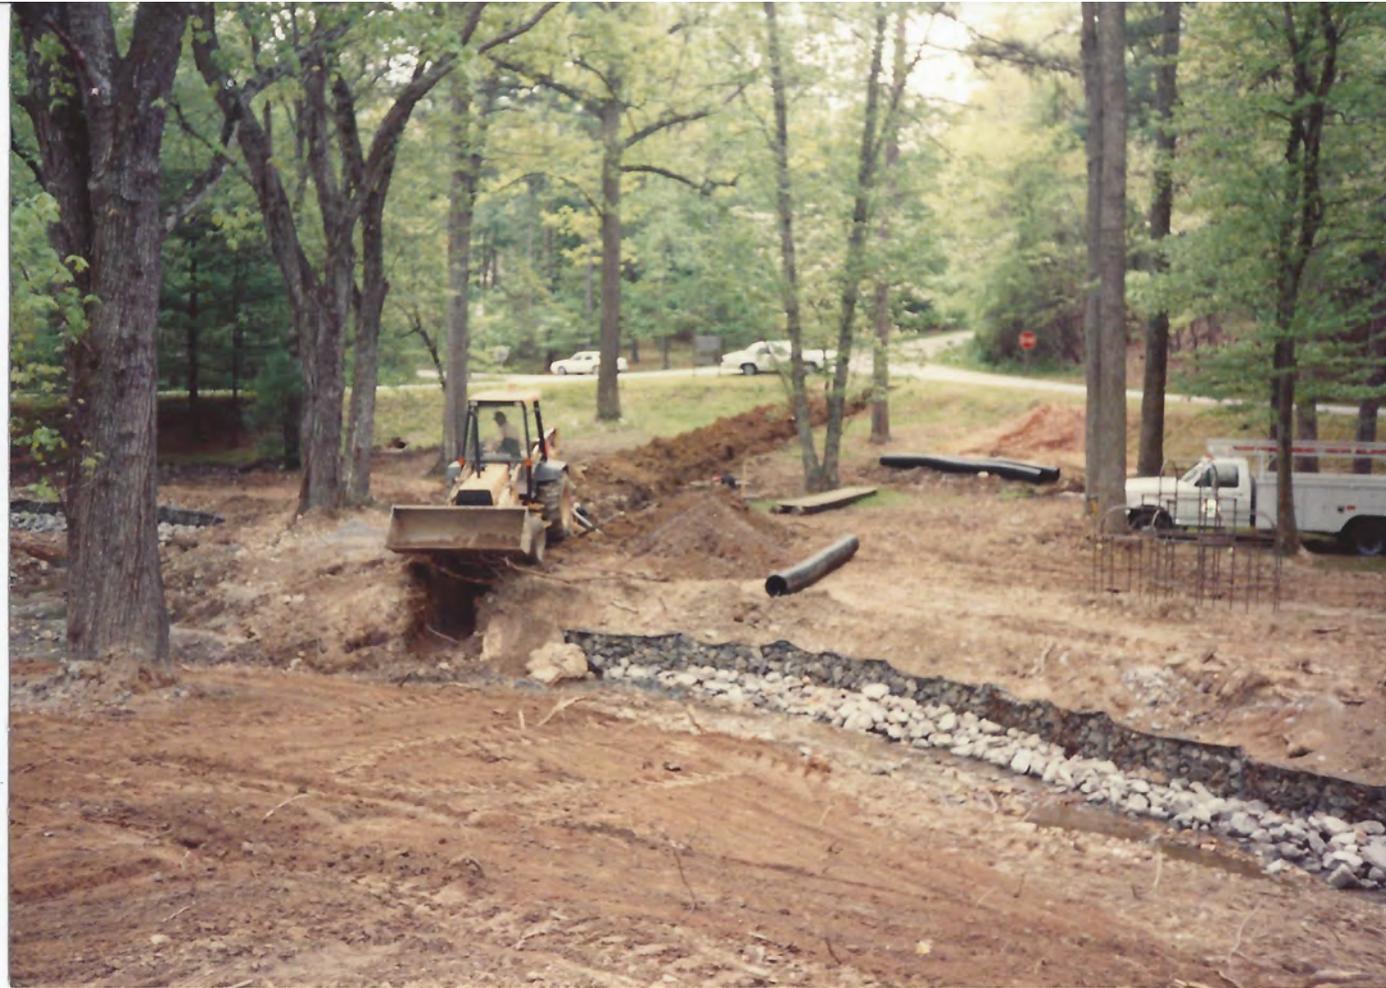
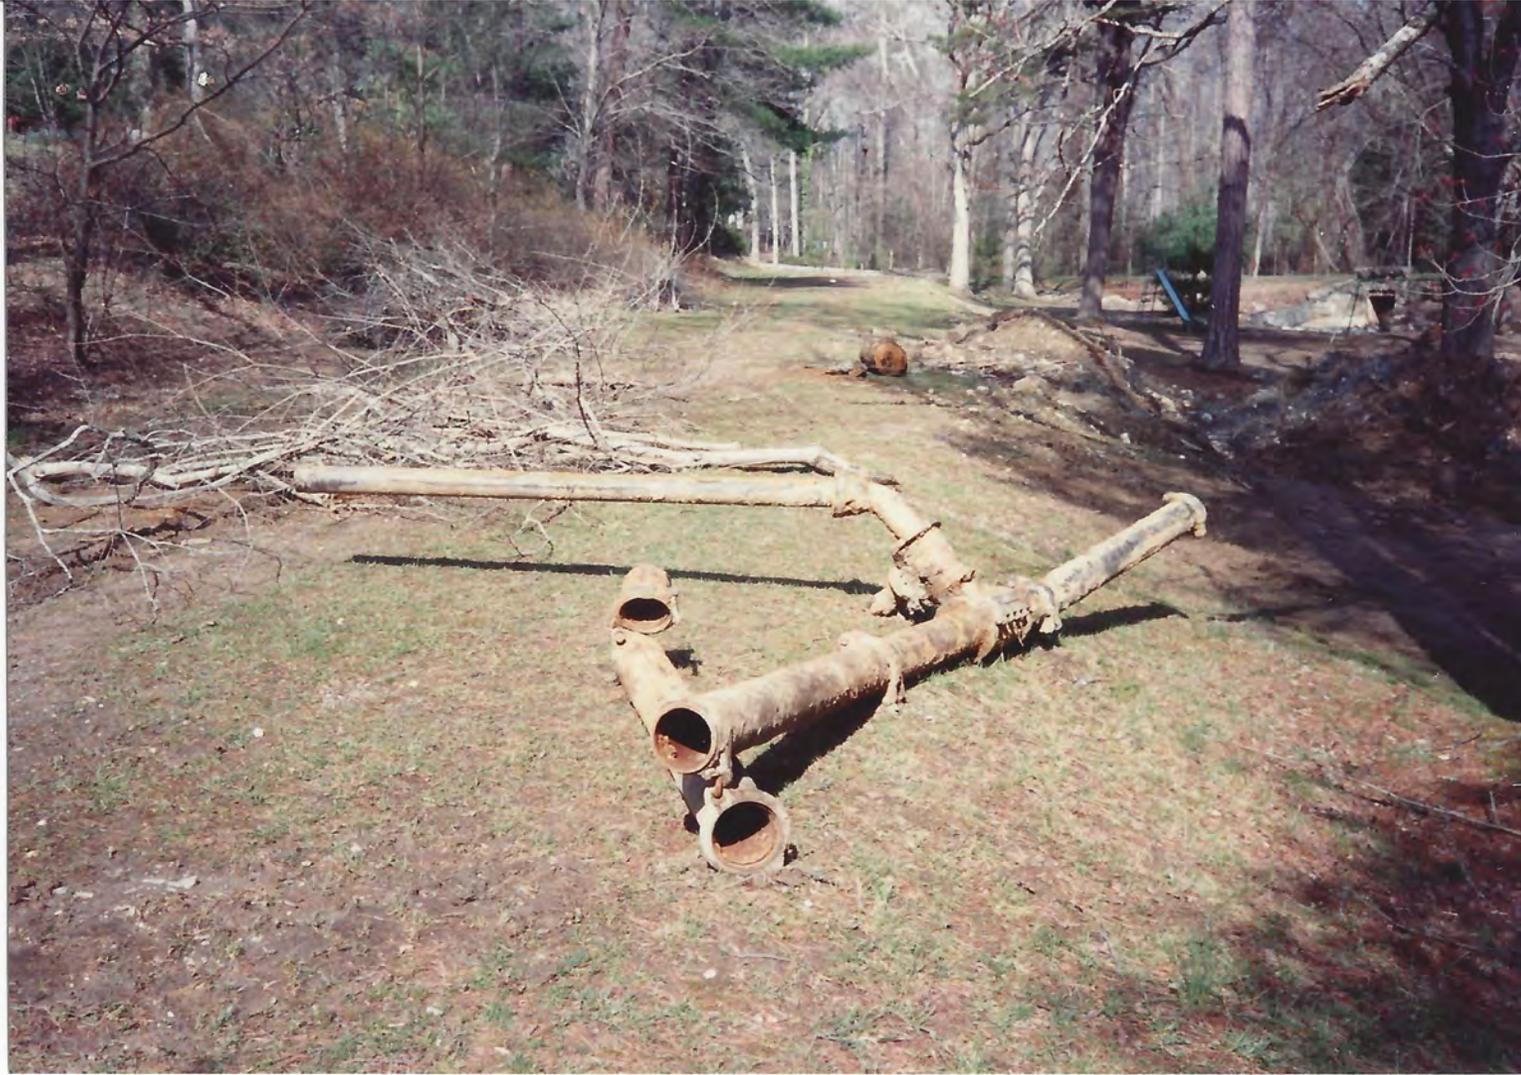
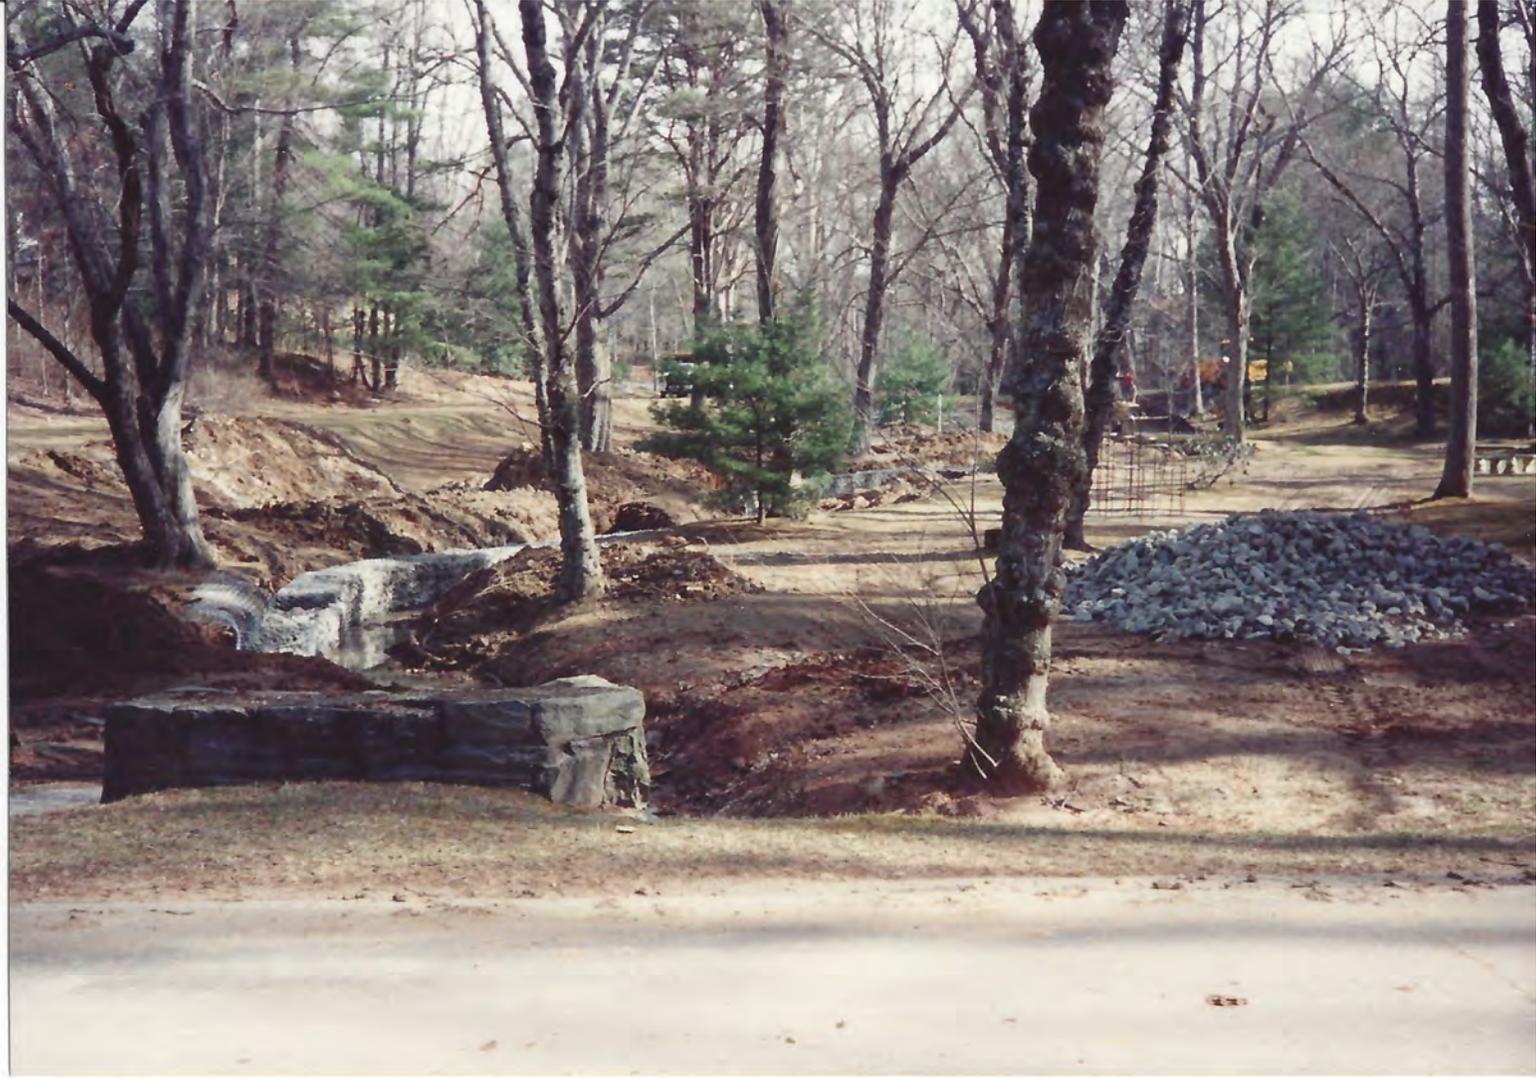
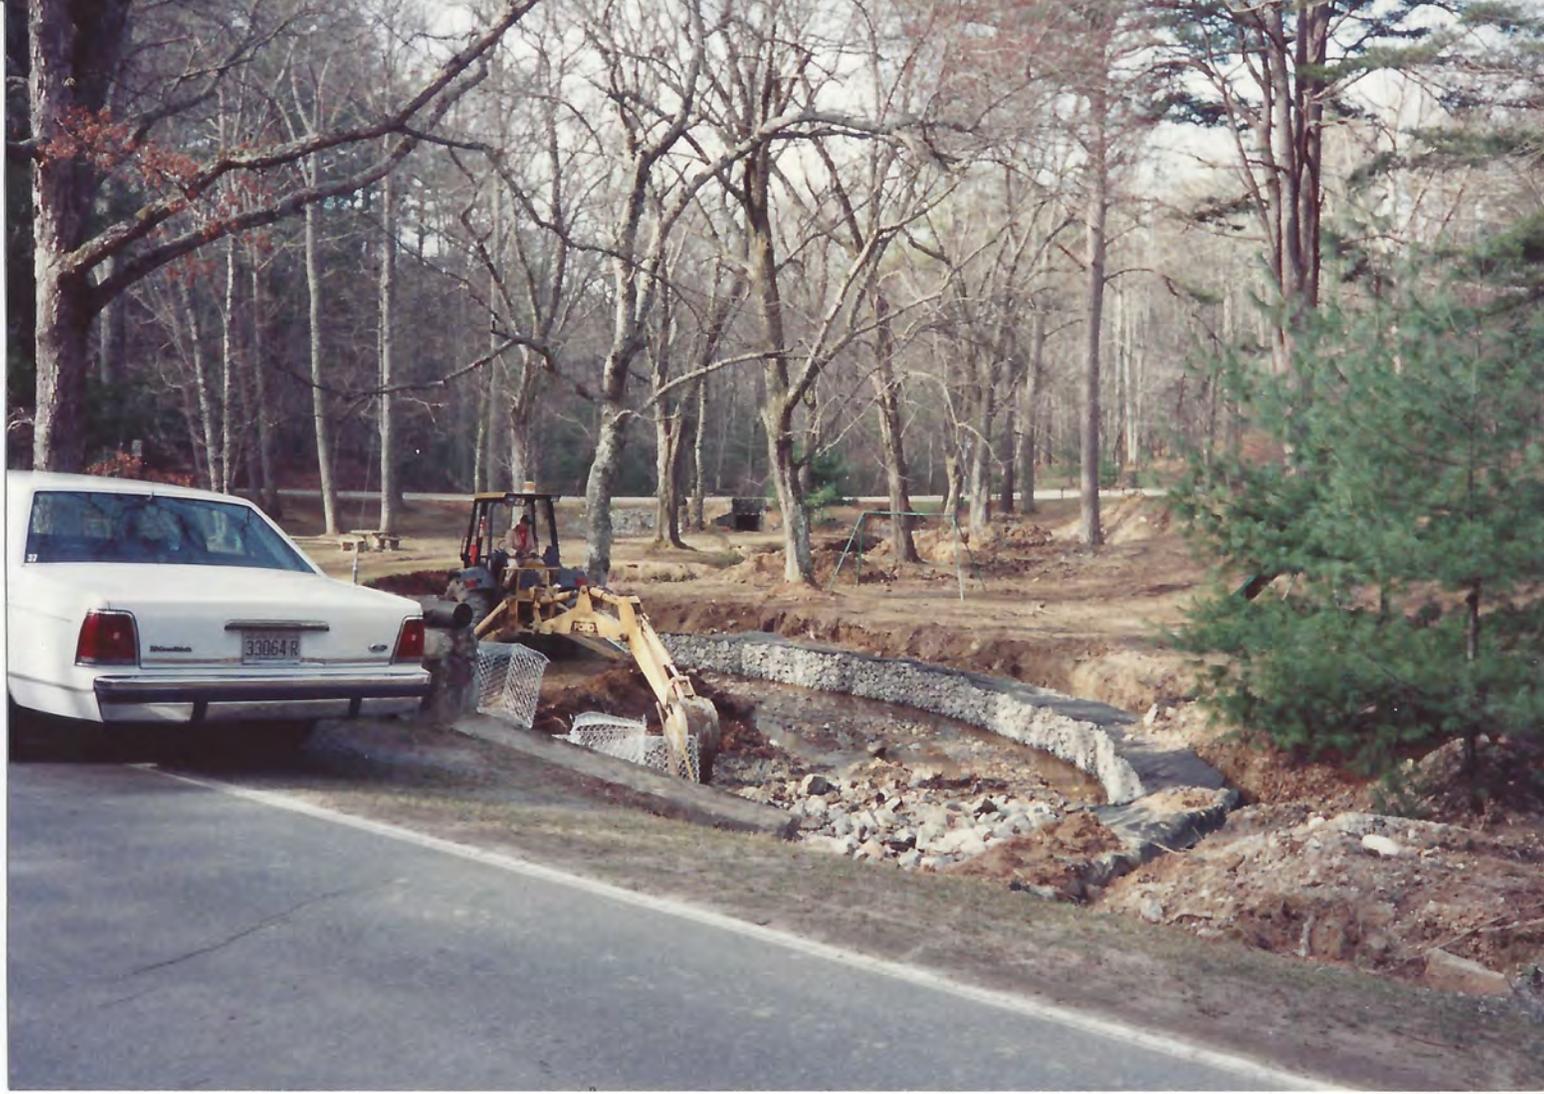
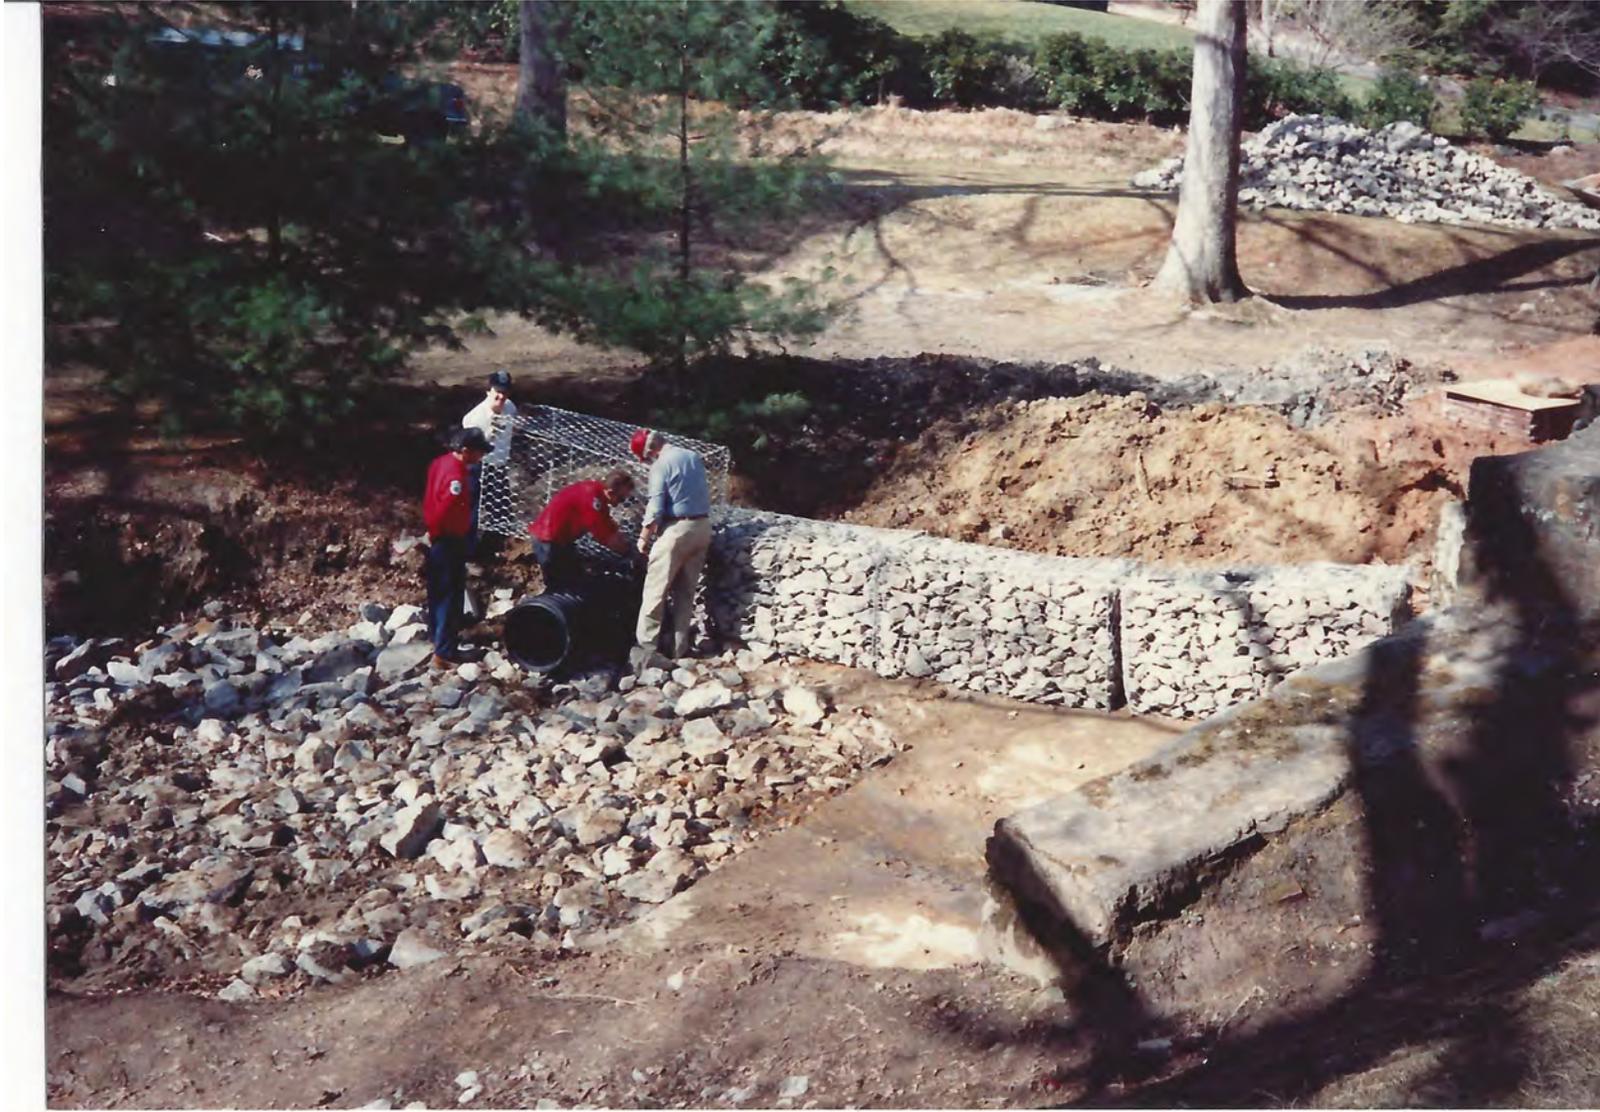
STREAM REPAIRS 1991-1992

- ADDITION OF STORMWATER DRAINAGE SYSTEM
- DEMOLITION AND RECONSTRUCTION OF WATER LINE STREAM CROSSING
- STREAMBANK STABILIZATION USING GABION BASKETS AND RIP RAP

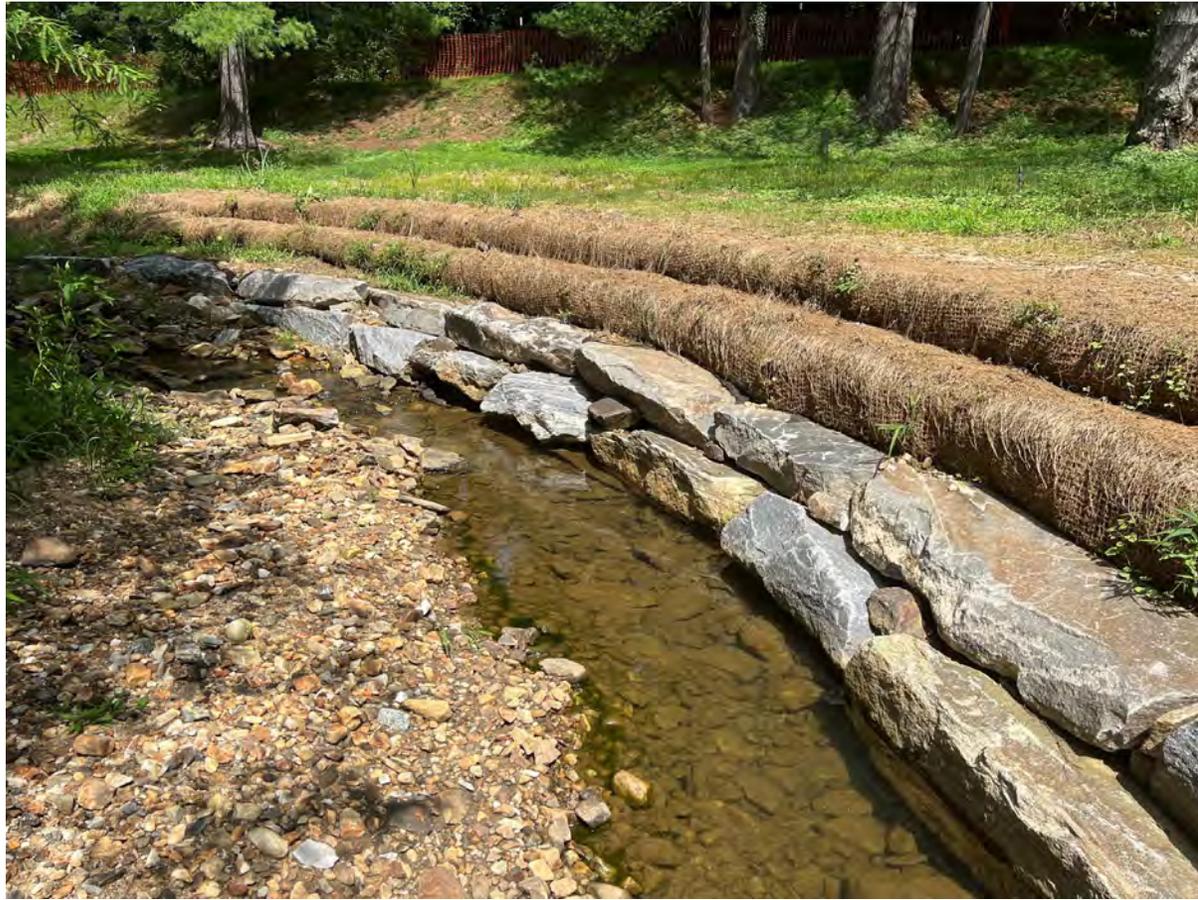
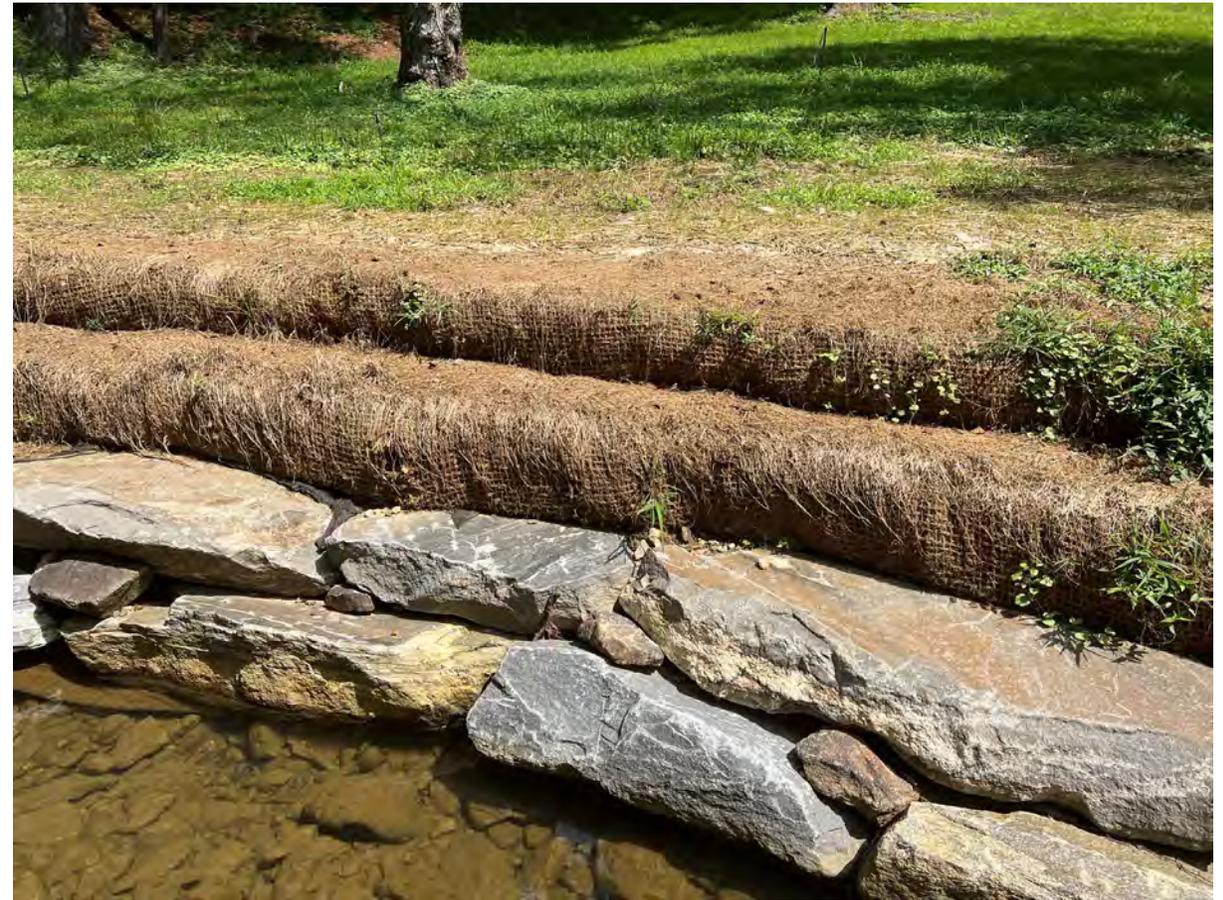
BOULDER TOE AND GEOLIFT

SLOPE STABILIZATION
